Manhole Inspection Summary

Manhole # S17AA2010MH

Insp Date: **4/3/07 9:38 AM**

Location Address: **1815 GREENBERRY RD**

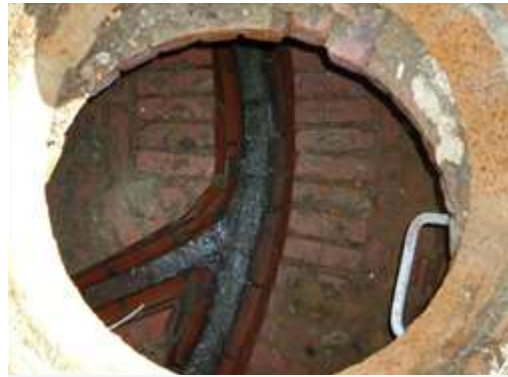
Top View

Bench ☒ Exists Material: **Brick** ☐ Parged ☒ **Debris** (not Condition related)

Surcharge ☒ **Evidence Of Surcharge** Depth: **1** (ft.) ☐ Active Surcharge Present

Evidence of surcharge - Bench debris.

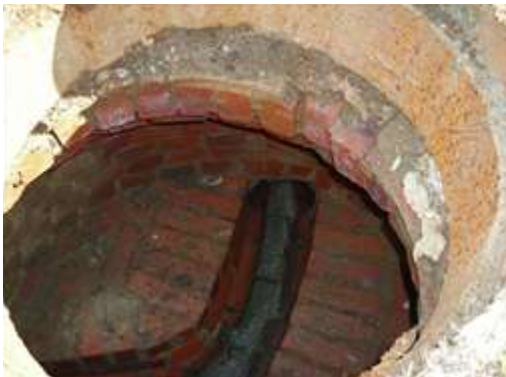
Defect

Frame Offset: **4** (in.) Condition: ☐ Sound ☐ Cracked ☒ **Leaks**

Condition: ☐ Sound ☐ Cracked ☐ Root Intrusion ☐ Loose Brick ☒ **Deteriorated**

Infiltration: ☐ None ☒ **Joint** ☐ Cracks ☒ **Mortar** ☐ Roots ☐ Wall

Infiltration: ☐ None ☐ Joint ☐ Cracks ☒ **Mortar** ☐ Roots ☒ **Wall**

Frame leaks. Frame offset. Adjustment deterioration and infiltration. Barrel infiltration.

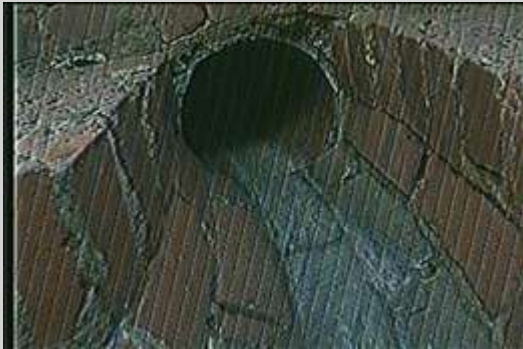
8 in. Circular Gravity Sewer Pipe Out @ 12 O'Clock

Infiltration: **Evidence** Pipe Seal Cond: **Broken**

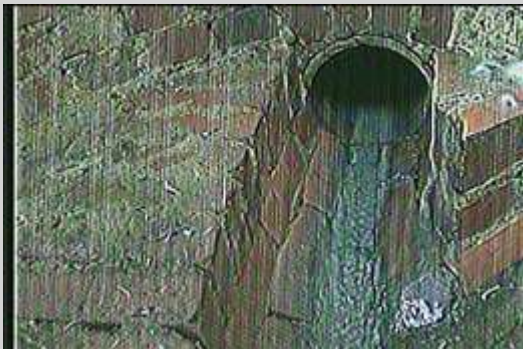
8 in. Circular Gravity Sewer Pipe In @ 7 O'Clock

Deposits: ☐ None ☐ Mud ☐ Sludge ☐ Debris ☒ Grease

Silt Depth: **0** (in.) Deposits Extent: **Light**

Infiltration: **Evidence** Pipe Seal Cond: **Cracked**

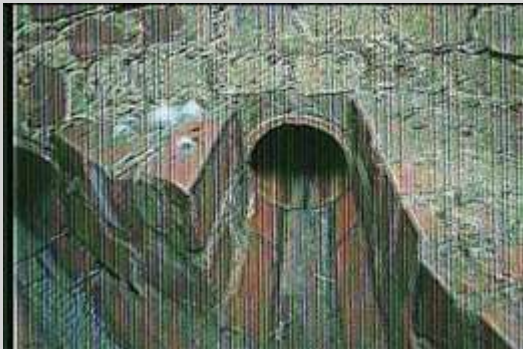
6 in. Circular Gravity Sewer
Pipe In @ 8 O'Clock

Barrel deterioration and infiltration. Channel deterioration.

Infiltration: **Evidence** Pipe Seal Cond: **Cracked**
